**PRELIMINARY ASSESSMENT/
VISUAL SITE INSPECTION**

**COMMERCE INDUSTRIAL CHEMICALS, INC.
MILWAUKEE, WISCONSIN
WID 980 795 181**

FINAL REPORT

Work Assignment No.	:	R05032
EPA Region	:	5
Site No.	:	WID 980 795 181
Date Prepared	:	March 16, 1993
Contract No.	:	68-W9-0006
PRC No.	:	309-R05032WI09
Prepared by	:	PRC Environmental Management, Inc. (Ken Valder)
Contractor Project Manager	:	Shin Ahn
Telephone No.	:	(312) 856-8700
EPA Work Assignment Manager	:	Kevin Pierard
Telephone No.	:	(312) 886-4448

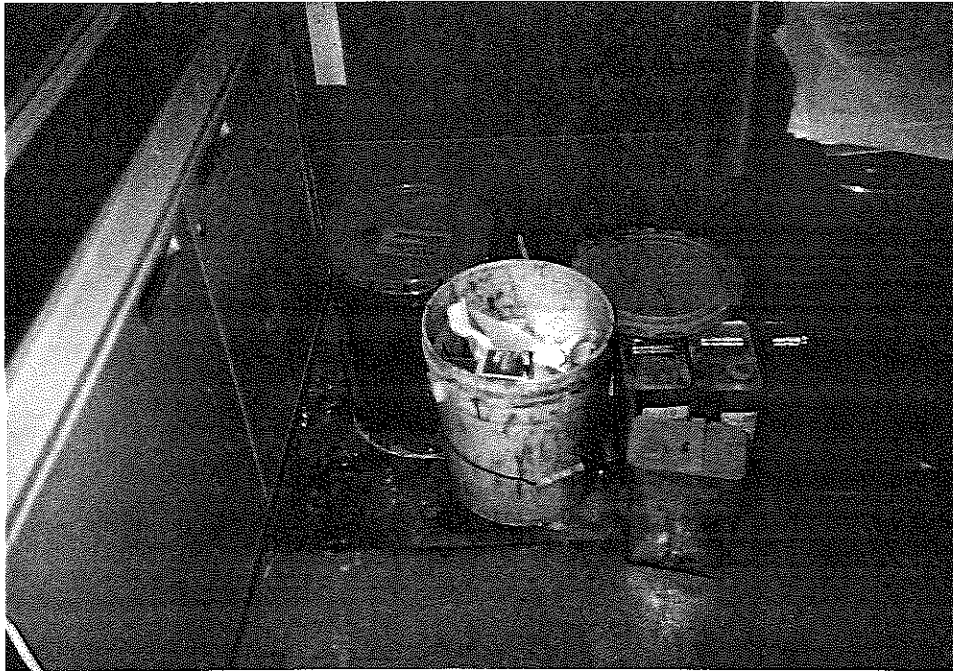
Photograph No. 3
Orientation: South

Description: This picture shows the Laboratory Waste Accumulation Area in the QC laboratory. The bucket with the blue lid is accumulating waste.

PRC recommends no further action.

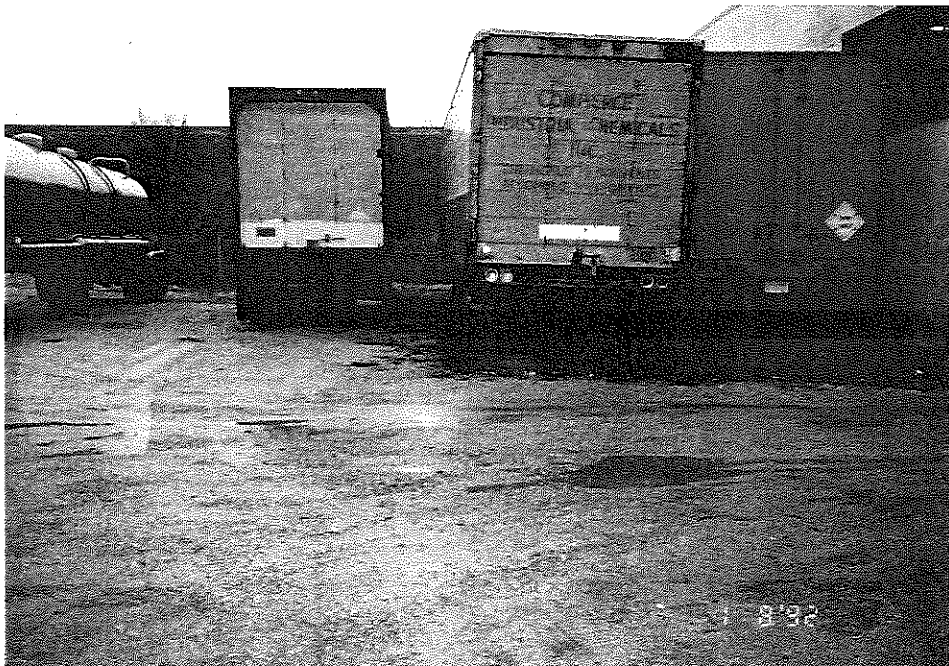
Photograph No. 4
Orientation: South

Date of Startup:	This unit was installed in 1982 or 1983. It was never operated.
Date of Closure:	Because the unit was never operated, closure was not required. It has been dismantled and removed from the facility.
Wastes Managed:	This unit was designed to incinerate various solvent wastes (D001, F003, F005, and K086).
Release Controls:	The unit was located on a concrete pad outside the facility. It had no emission control equipment because combustion of wastes was expected to be complete.
History of Documented Releases:	No releases from this SWMU have been documented.
Observations:	The Hazardous Waste Incinerator was not on site during the VSI. The concrete pad on which the unit was installed was unstained, and PRC did not observe any evidence of a release from this unit.

Location: East end of facility
Date: 01/08/92

PRC recommends no further action.
